# Composite Repair System

Belzona SuperWrap II is a composite repair solution designed to restore strength to weakened or holed metallic substrates. Developed for applications on pipes and process vessels, it is also suitable for safety critical and pressurised systems, and can be used on bends, tees and other complex geometries.

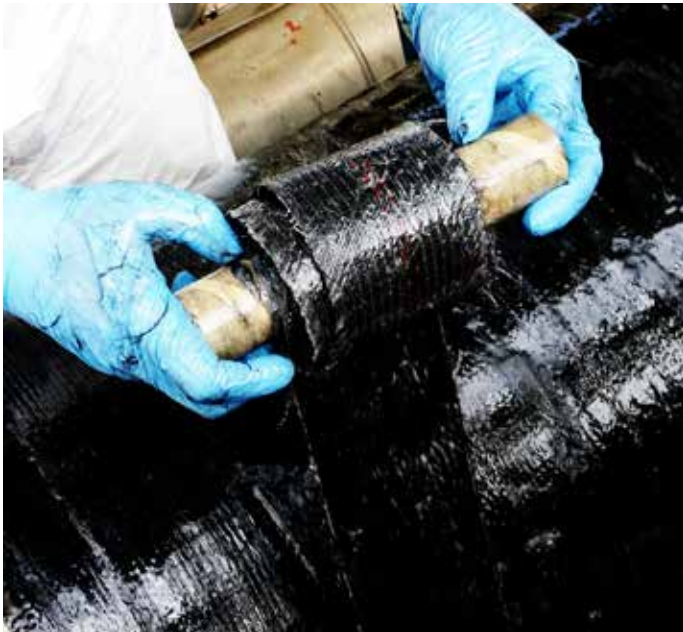
A unique combination of a 100% solids resin, carbon and glass fibre reinforcement sheet, and a compression film ensures a quick and simple application. It can remain maintenance-free for up to 20 years.

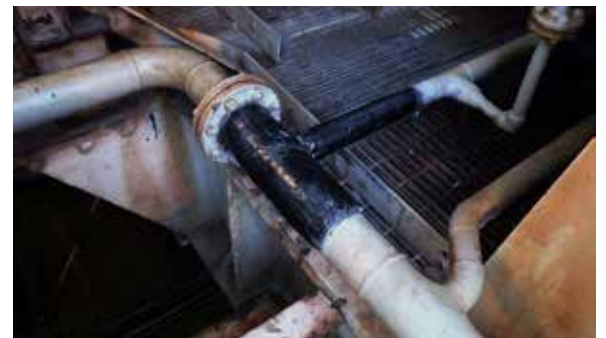
## Belzona SuperWrap II Components:

- Choice of resin

Belzona 1981, Belzona 1982 or Belzona 1983

- Belzona 9381

Glass and carbon fibre blend reinforcement sheet

- Belzona 9382

Release film for wrap consolidation
